Emergency Action Plan (EAP)
For
Lake Creek Dam (L-24)
Osborne Creek Dam (O-15)
Woodrat Knob Dam (W-43)

Located in
Jackson County

Prepared For
B Bar K Cascade Ranch
February 3, 2017

With Support from
The Oregon Water Resources Department Dam Safety Program

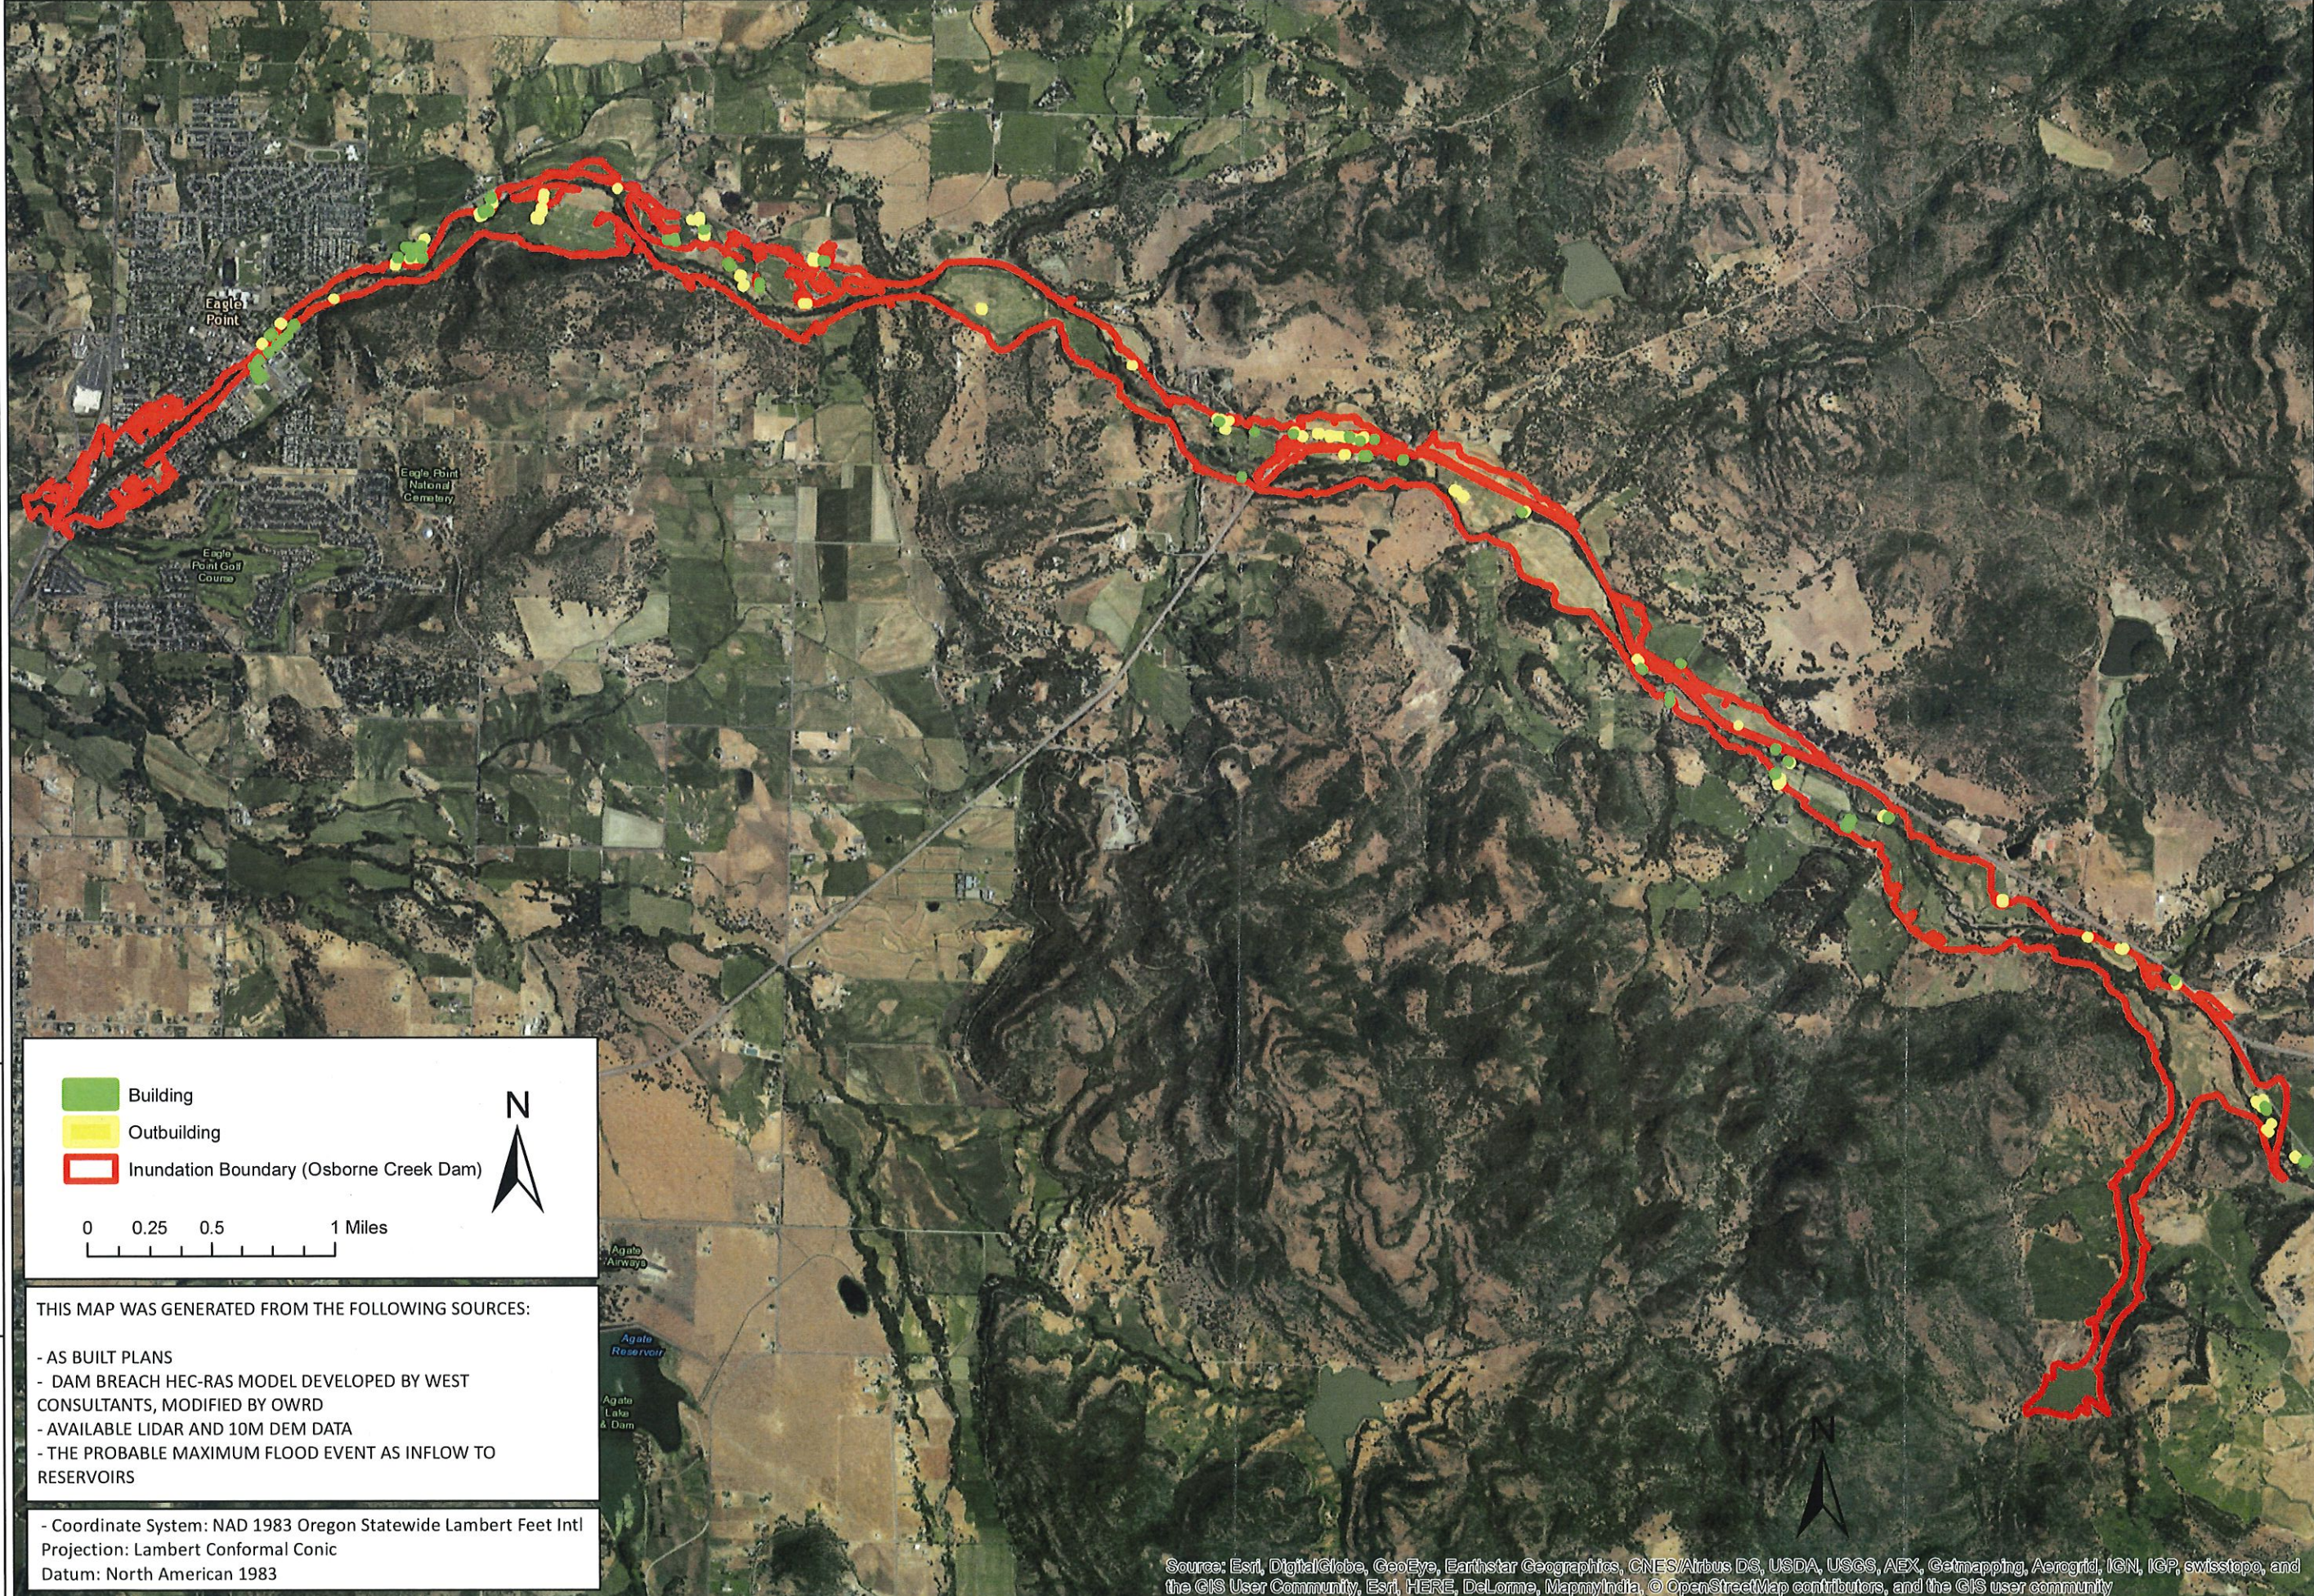
SHEET	DRAWING STATUS: FINAL	JACKSON COUNTY OSBORNE CREEK DAM DAM BREACH INUNDATION MAP	OREGON	OREGON WATER RESOURCES DEPARTMENT DAM SAFETY 725 SUMMER ST. SUITE A NE SALEM, OR 97301	DESIGNED BY

Potential Impacted Area: Dam failures may inundate lower Lake Creek downstream along Little Butte Creek, including a significant part of Eagle Point
